Re: Mesquite Generating Station
CEC Decision No. 63232
Docket No. L-00000S-00-0101
2010 Annual Report

**Certificate of Environmental Compatibility
2010 Annual Status Report
Mesquite Power Project
Docket No. L-00000S-00-0101**

Report to the Arizona Corporation Commission on the Mesquite Power/University of Arizona Desert Revegetation Experimental Planting

Prepared by T.M. Bean and M.M. Karpiscak, University of Arizona School of Natural Resources and Environment
12 November 2010

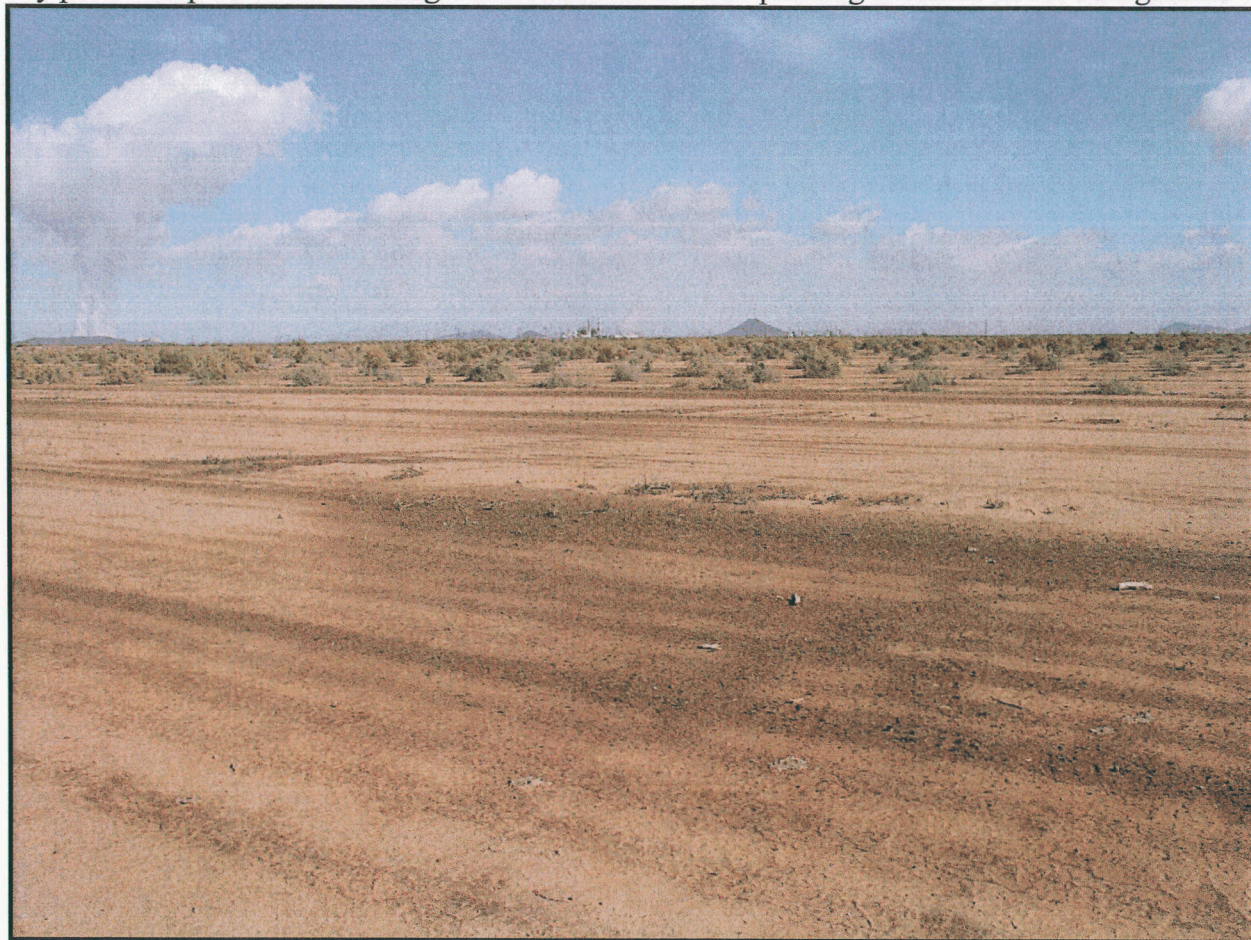
Figure 2: A typical un-revegetated field prior to planting. This small part of one field was left un-planted to use as a control site to compare to fields that were to be planted. Note the lack of any perennial plant cover in foreground. The March 2002 planting is visible in the background.

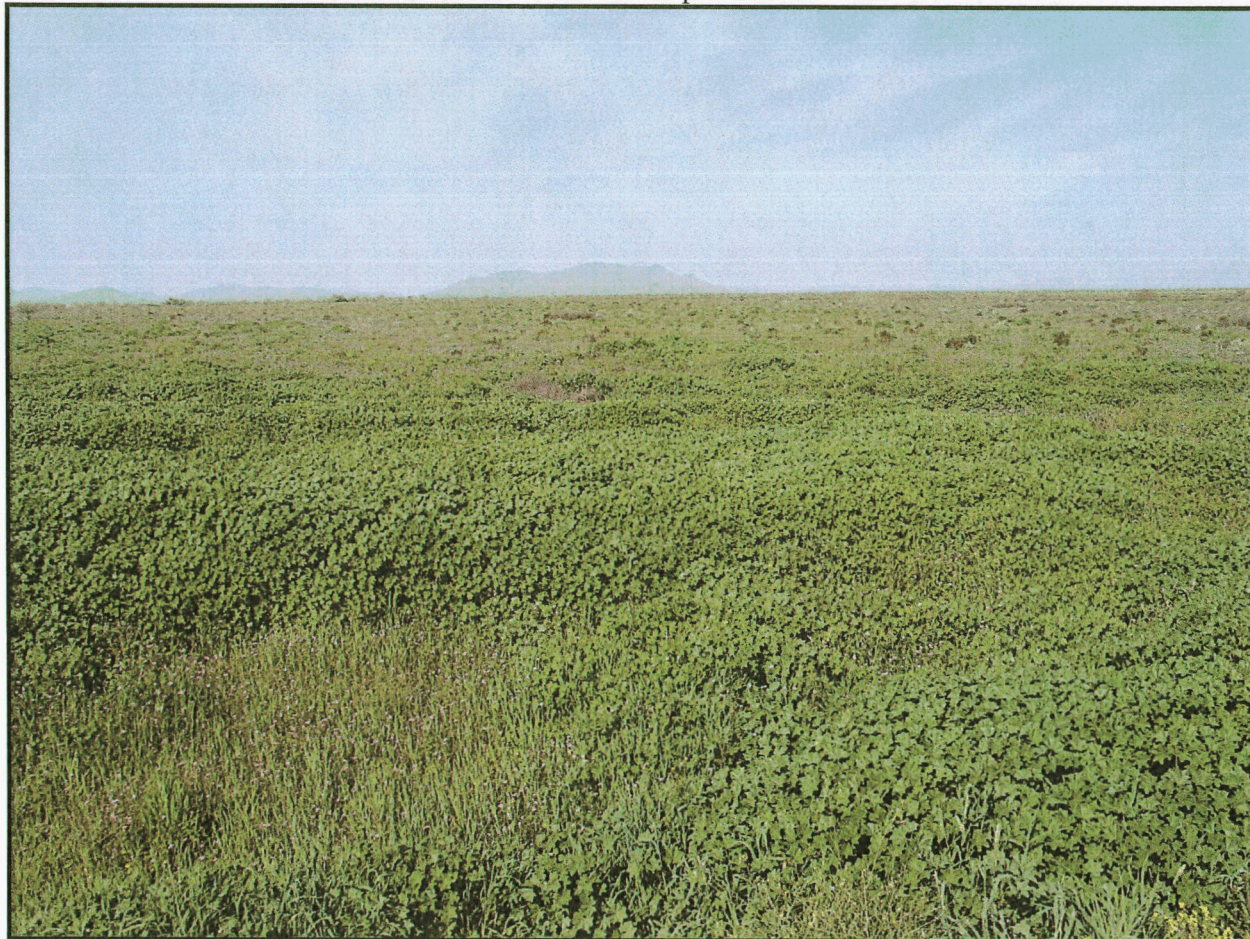
Figure 5: Photograph Showing Rank Growth of Winter Annual Weeds in 2005 that Prevented Plant Field Counts. This view is of one of the fields planted in 2003.

western and southern boundaries. This planting was completely covered by a rank growth of annual weeds that occurred in 2004 through 2006 (Figure 5). Prior to extreme flooding events in winter 2009/2010, visual results of the planting are quite satisfactory with *L. tridentata* doing particularly well in this planting. However, current data indicate that *L. tridentata* suffered significant mortality from the prolonged flooding (198 plants ac^{-1} [489 plants ha^{-1}] in 2009 to 98 plants ac^{-1} [242 plants ha^{-1}] in 2010), as seen in Figure 6.

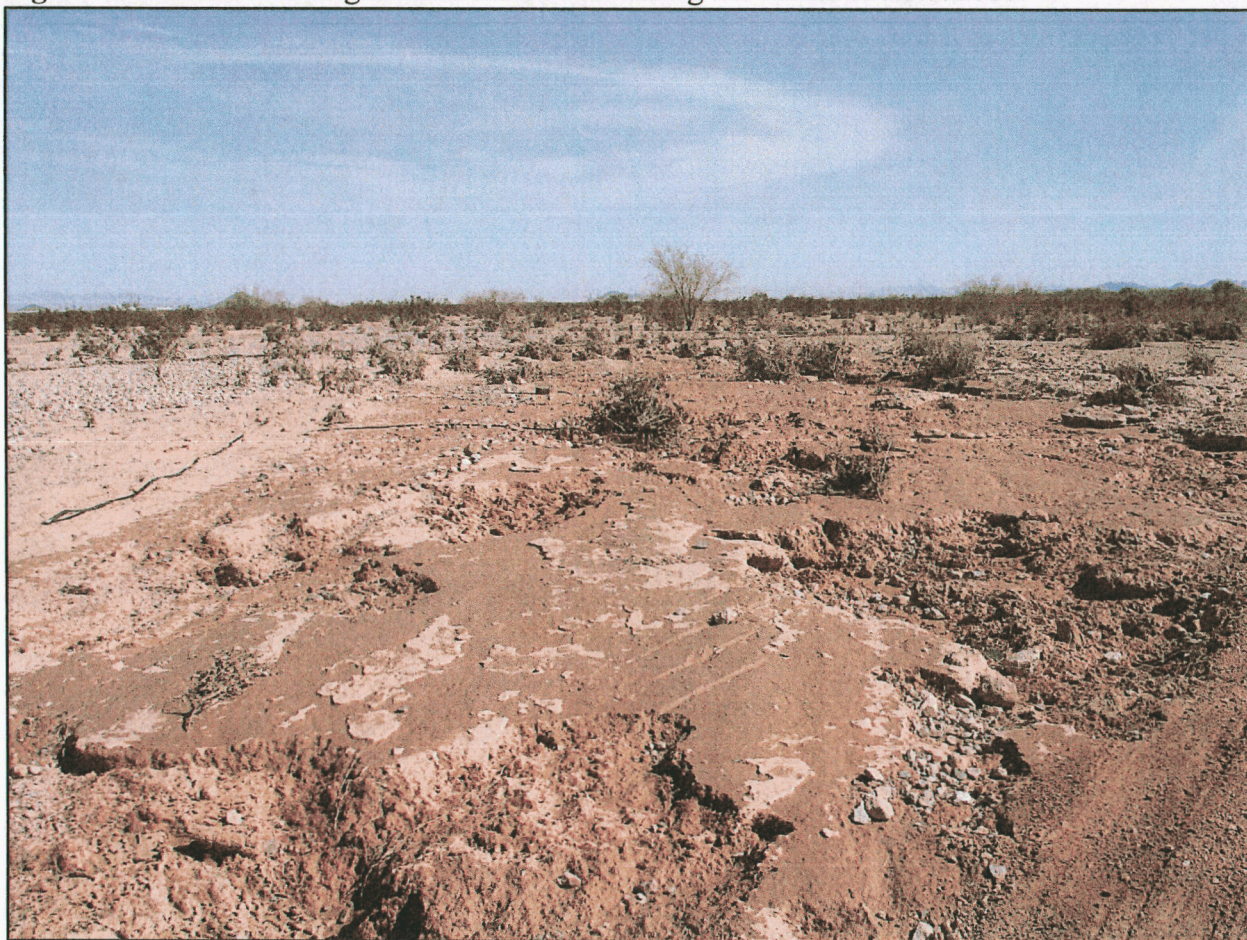
Figure 6: Extreme flooding occurred in Field 2 during the winter of 2009/2010.

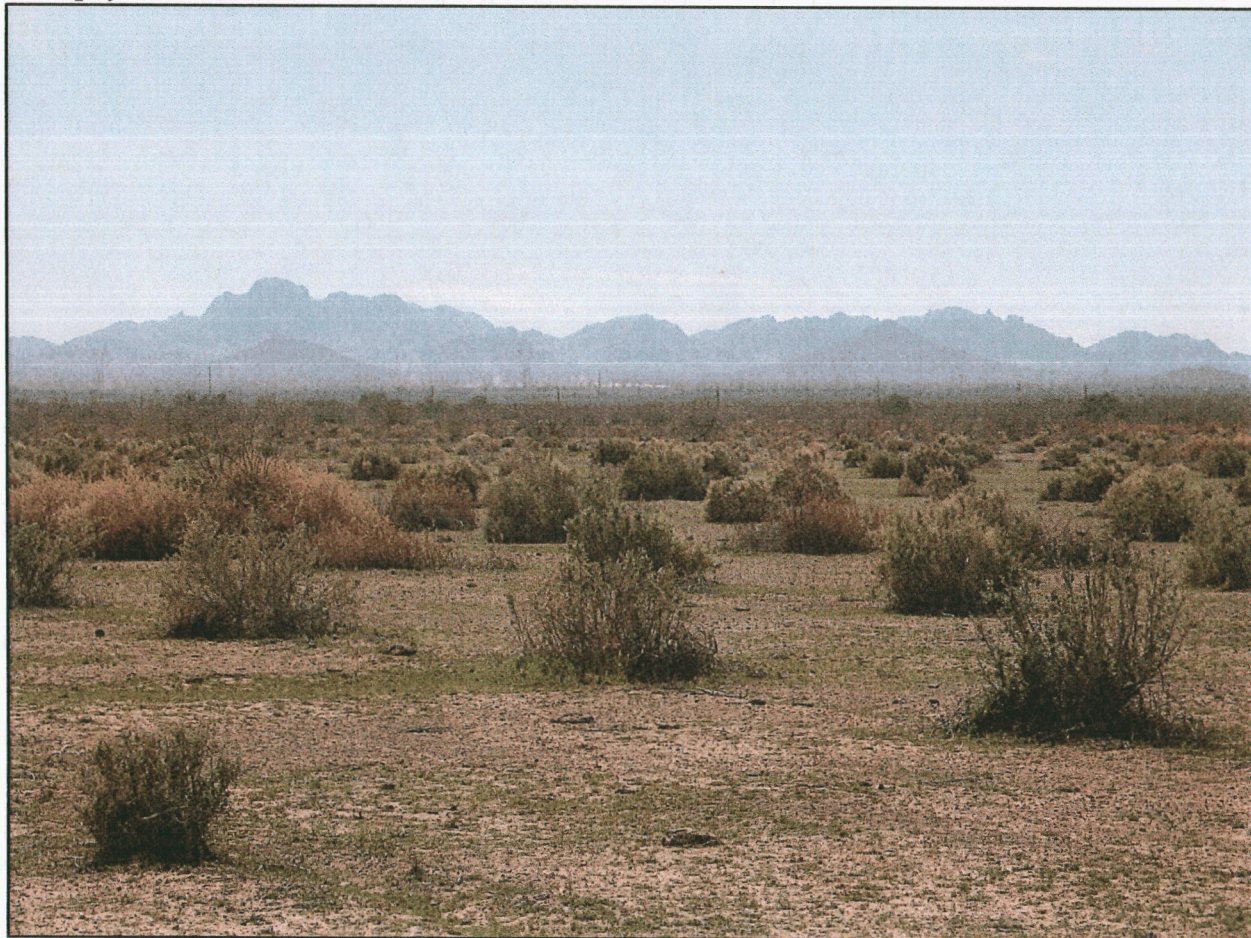
Figure 12: A 2010 view of Field 3. This field had high survival and establishment of planted species, and current dominant perennial plants include *A. dumosa*, *A. polycarpa*, *L. tridentata*, *P. microphylla*, and *P. velutina*.
